TMDL Program Six Year Progress Report

2000 - 2006

Prepared by the Virginia Department of Environmental Quality
in cooperation with the Departments of Conservation
and Recreation and Mines, Minerals, and Energy

March 2007

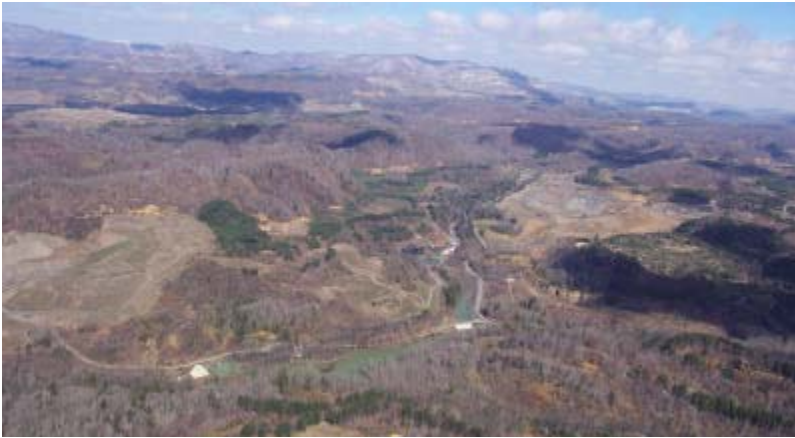
Figure 5.6.2 Remining operations in Black Creek, Wise Co.

Red River Coal Company's operations plans include reclamation measures specifically designed to address the stream's impairment source. The plans include elimination of a large underground mine area via daylighting – uncovering the mine voids and purging the acidic waters - and the reclamation of about 300 acres of AML. The reclamation practices include regrading and revegetating eroding outcrops and eliminating existing highwalls. The reclamation measures should reduce the stressors identified in the TMDL study.

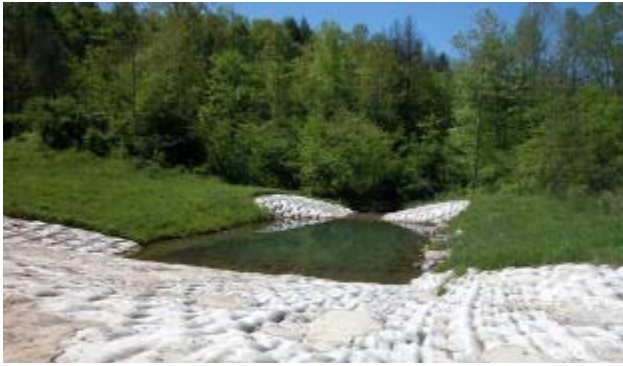
Figure 5.6.4 Wetland outlet structure

DMLR received 319 funding from EPA and Clean Streams Initiative funding from OSM to assist with the wetland enhancement project. The money was used to design and construct two outlet structures in Black Creek, as well as, purchase and plant wetland species. The structures regulate the flow of the stream and expand existing wetland areas. The outlets were constructed by creating a dam with grout filled bags and installing decant pipes beneath the dam to control wetland water level. After they were established, the additional wetlands have naturally reduced AMD. The wetland plants are taking up metals and reducing the instream concentrations plus the wetlands have increased metal precipitation and reduced downstream concentrations. Figure 5.6.4 displays the downstream outlet structure.

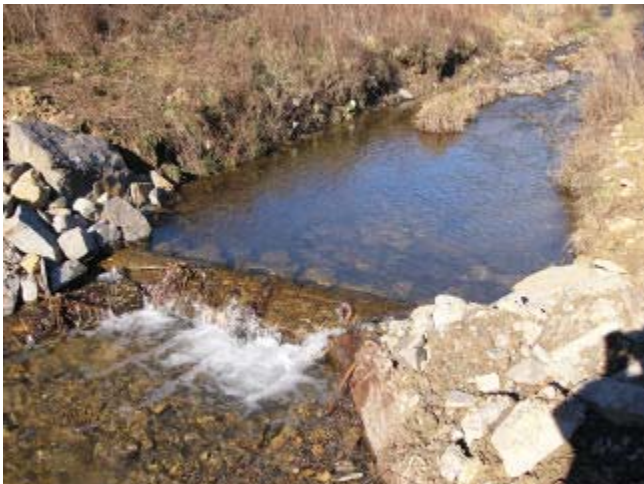
Figure 5.6.5 K-dam in Black Creek, Wise Co.

DMLR received funding from the National Fish and Wildlife Foundation to complete a habitat improvement project. The money was used to evaluate the lower reaches of Black Creek, identify habitat improvement needs, design improvement structures, and install structures. DMLR contracted with Virginia Tech for the work. The project has resulted in the creation of five pool areas in the lower reaches of the stream by installation of small stream habitat improvement structures. The structures' primary purpose is to diversify the stream morphology and improve aquatic habitat. Figure 5.6.5 illustrates the habitat improvement structures.

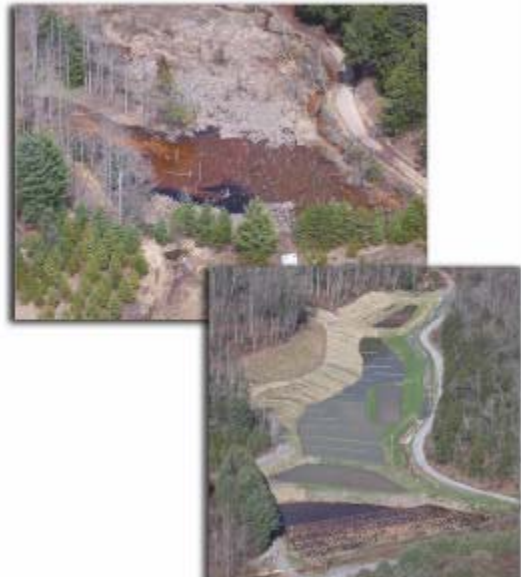
Figure 6.7.1 Ely Creek AMD before and after reclamation, Lee Co.

In the Powell River, Lee County, the Department has chemically improved several miles of stream through completion of the Ely Creek acid mine drainage wetland; a cooperative project between DMME and the U. S. Army Corps of Engineers. The second phase of the project has been initiated and will also consist of wetland construction in Puckett Creek. Ely Creek and Puckett Creek are tributaries to impaired segment of the Powell River.

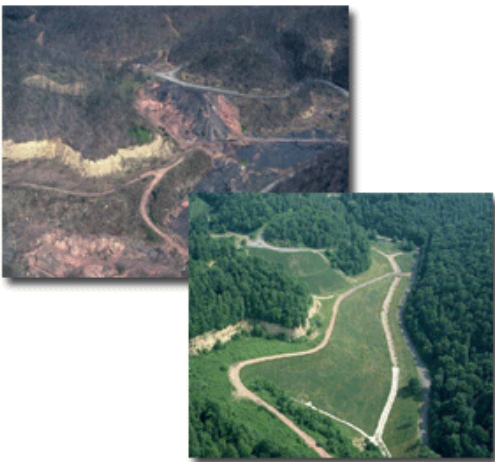
Figure 6.7.2 Straight Hollow gob pile before and after reclamation, Russell County

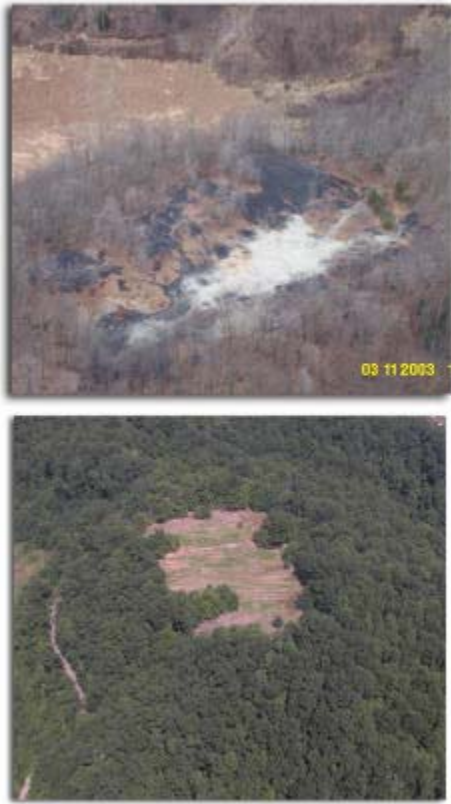
Figure 6.7.3 Abandoned refuse area before and after reclamation, Wise Co.

Water Quality Improvement Act funding was successfully solicited by the Department, as well as local Soil and Water Conservation District partners, to reclaim several AML sites currently contributing pollution loads to impaired streams. The projects include sites in Knox Creek & Levisa Fork in Buchanan County, Guest River in Wise County, and the Powell River in Lee County.
